# **Callide Power Station Unit C3 Incident Report**

# **Callide C3 Significant Pressure Event**

Root Cause Analysis Investigation Report

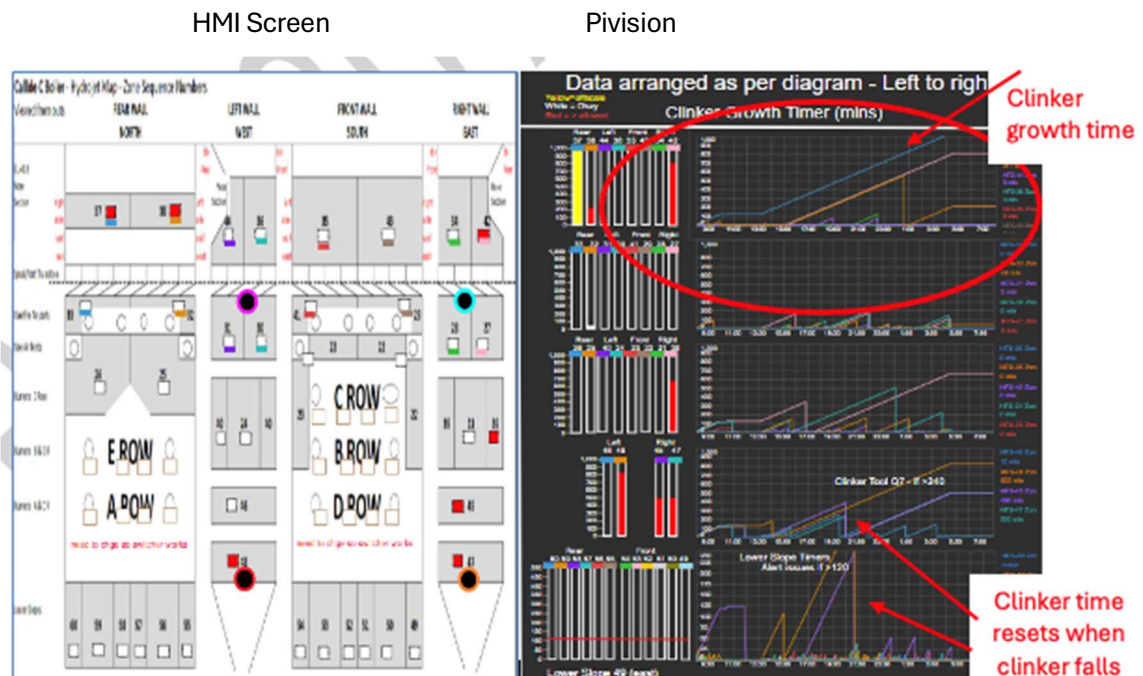
**Figure 9 - Furnace Conditions at the Time of the Clinker Event**

Following the clinker deload conducted on 3 April, two further assessments were completed at 02:50 and 04:21 using the Clinker Assessment Tool and Hydro Jet monitoring screen. These are the primary tools available to operators for evaluating clinker formation and furnace fouling. Neither assessment indicated that a deload was required. However, at approximately 04:35, a large clinker fell from the furnace wall, directly contributing to the event.

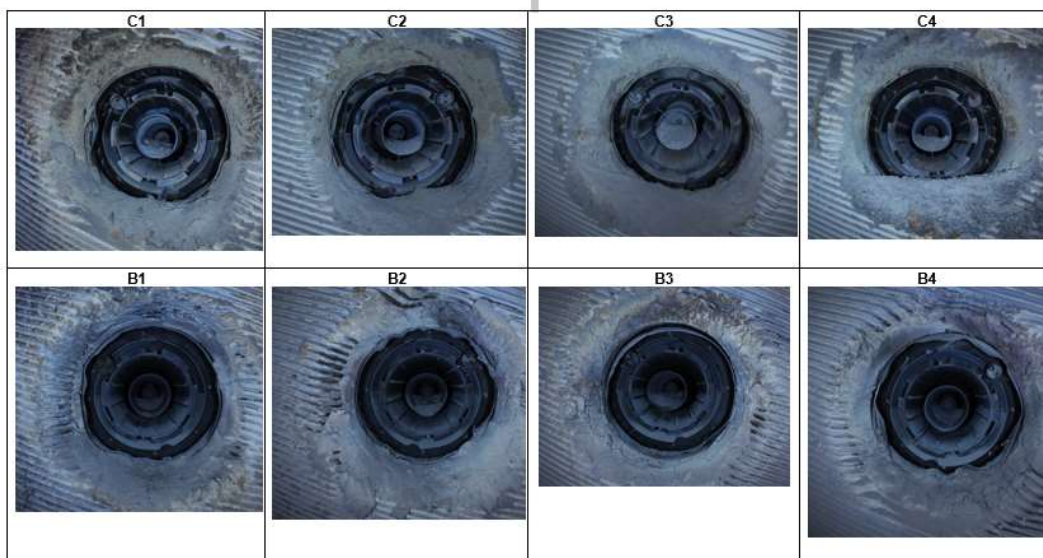
**Figure 16 - Pulverised Fuel Burner Conditions on C and B Mills photos taken by drone**

Boundary air is important in clinker management because Iron oxide is very sticky but rapidly oxidises to a less sticky form of iron oxide in the presence of any oxygen; it uses the oxygen much faster than char particle combustion dynamics. Hence boundary air helps form friable deposits rather than dense vitrified deposits. There is currently no performance standard acceptance criterion for the burners.

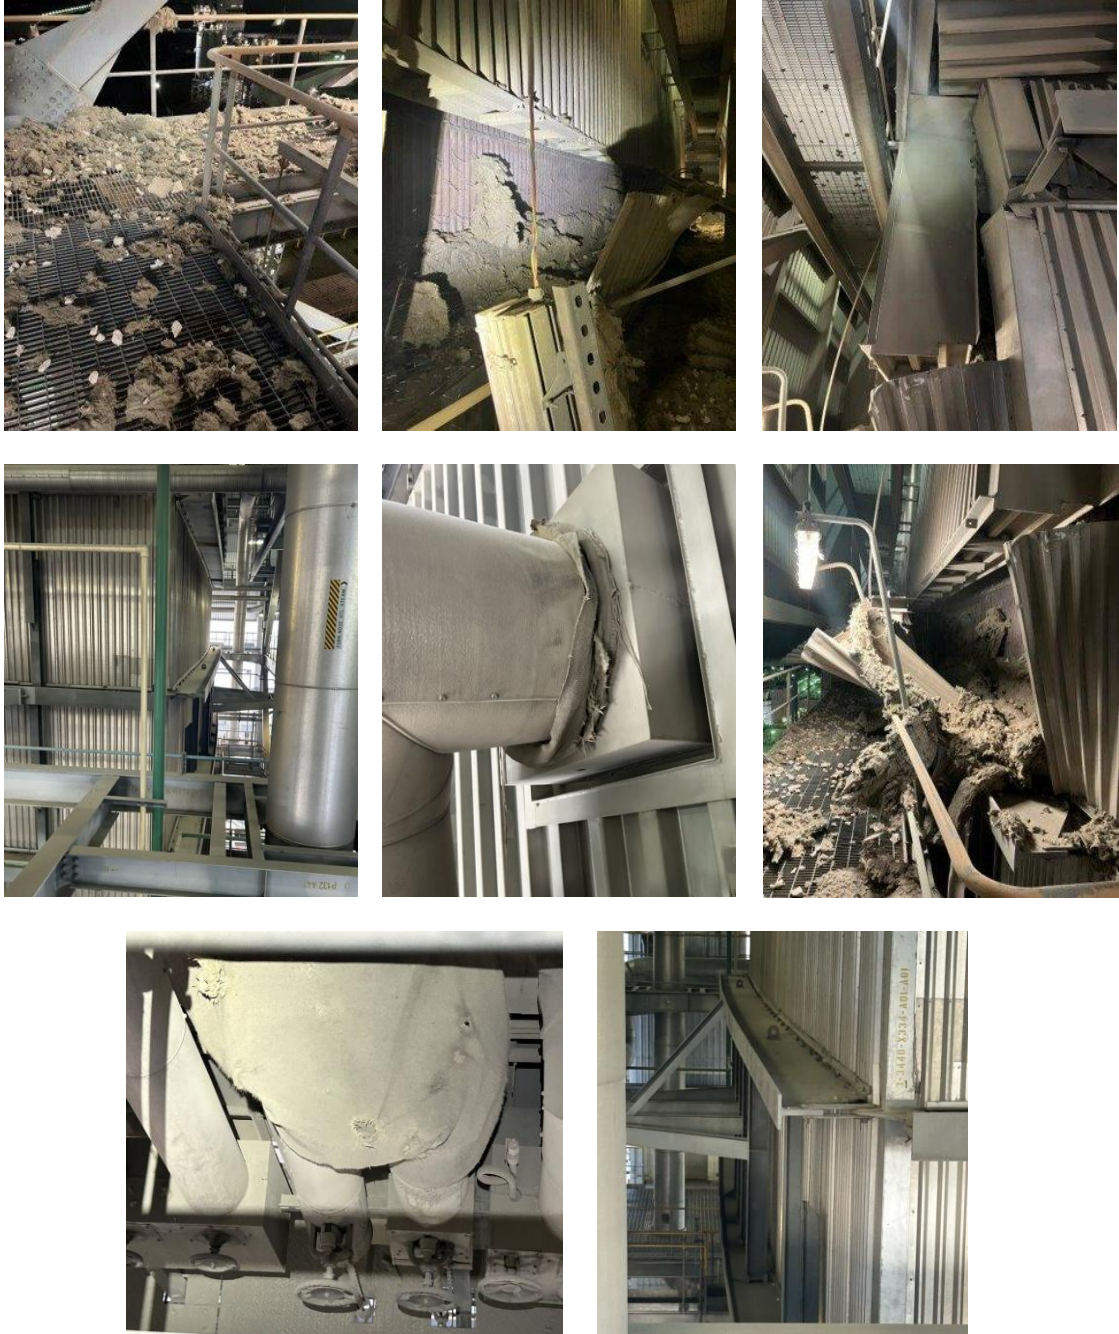
**Figure 6 - Damage Caused by the Incident**

The overpressure event caused visible damage to sections of the boiler casing, disrupted furnace insulation, and damaged nearby access platforms. Minor repairs were required to the ash handling system and furnace sealing components.

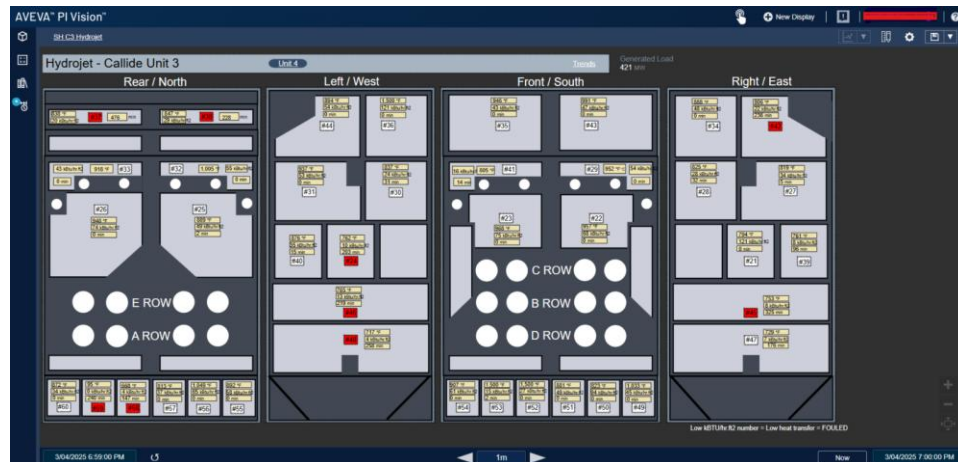
**Figure 13** - 9 Red Zones Indicating Clinker Growth from PI Vision on 3 April 2025, 19:00 Handover

However, there was no record of the red zones or clinker risk documented in the 19:00 J5 shift handover notes on 3 April. Refer to Section 6.2.2 which highlights shift handover as a contributing factor.

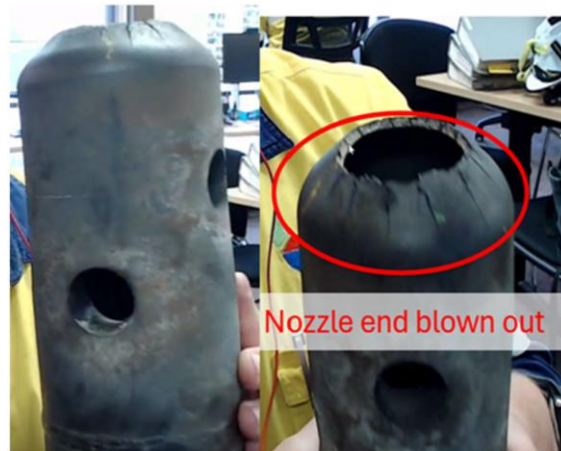
**Figure 16.2 - Damaged Sootblower Nozzle**

The nozzle damage occurred sometime between C3 Unit Return to Service (RTS) in April 2024 and the time of the incident, as the nozzles had been replaced during the previous outage. Although visually similar, the replacements were confirmed to be the wrong material. The correct nozzles are made from 304H stainless steel, suitable for high-temperature use, while the installed ones were 303 stainless steel.
