Callide Unit C4 turbine generator failure – 25 May 2021

Technical investigation summary

13 February 2024

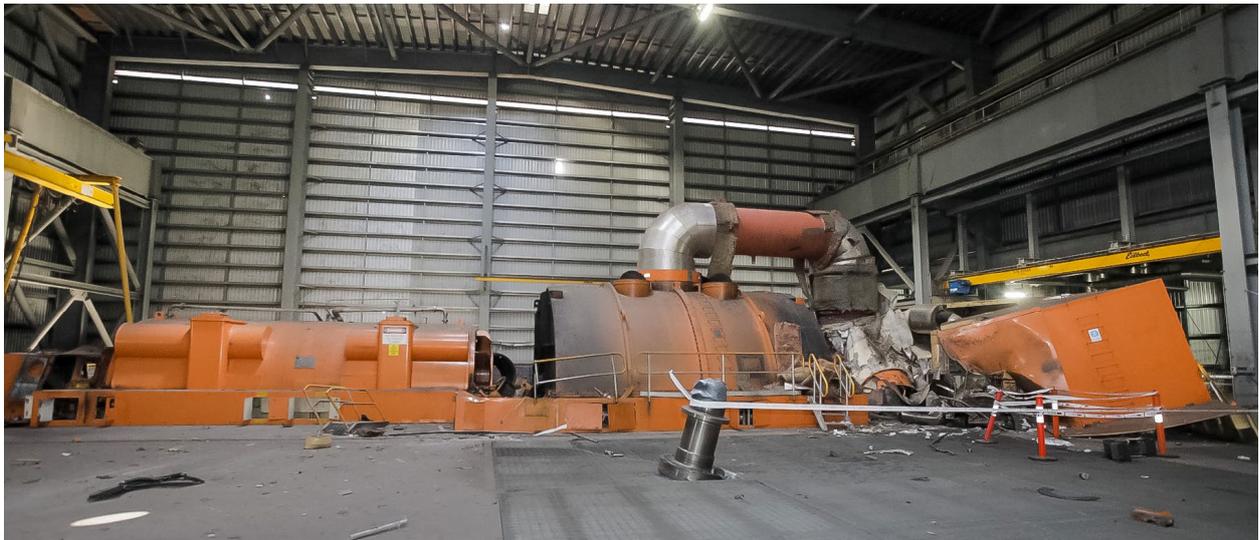
Figure 1: Unit C4 – post-event photograph

Post-event damage assessment identified the following:

- Considerable damage to the high pressure (HP), intermediate pressure (IP) and low pressure (LP) turbines including multiple shaft failures. Complete replacement was required.
- Considerable damage to the generator stator, rotor and exciter. Complete replacement was required.
- Insulation failure of the generator transformer and 275 kilovolts (kV) landing structure. Complete replacement was required.
- Impact damage to the condenser.
- Impact damage from debris to the turbine hall structure and the adjacent unit (C3).

Damage to Unit C4 was principally contained to the turbine floor with minimal impact to the boiler and turbine auxiliary equipment.

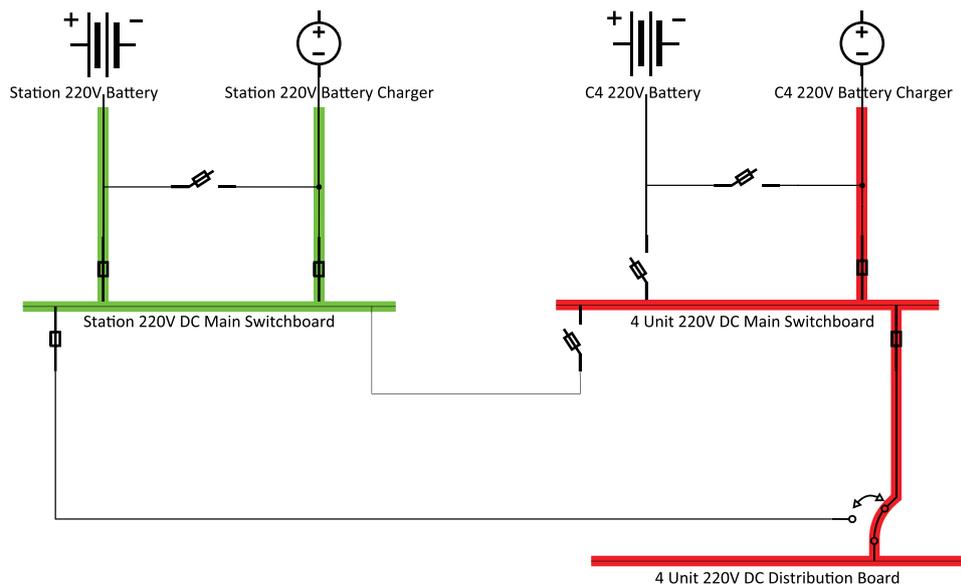
Figure 5: DC configuration 25/05/2021 13:34. Colours denote different circuits.

13:33	Unit C4 to Station Interconnector opened (initiating event), Unit C4 220V DC voltage decayed to zero volts.
--------------	---

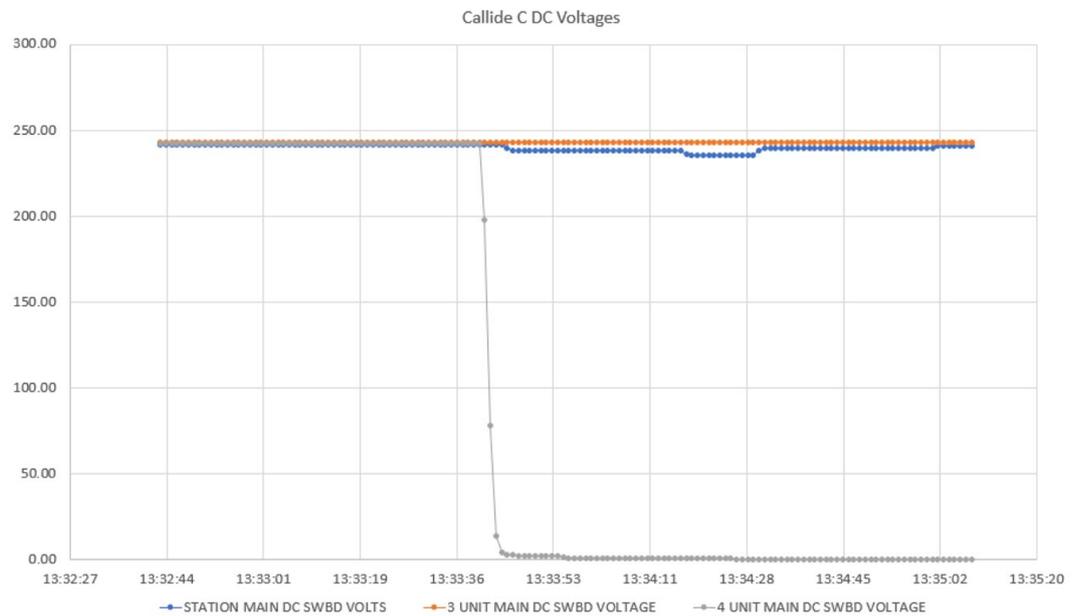
Figure 6: DC voltage data

13:33 Callide C DC voltage data is shown in Figure 6.

13:33–13:34 The decaying DC voltage on C4 triggered several events.

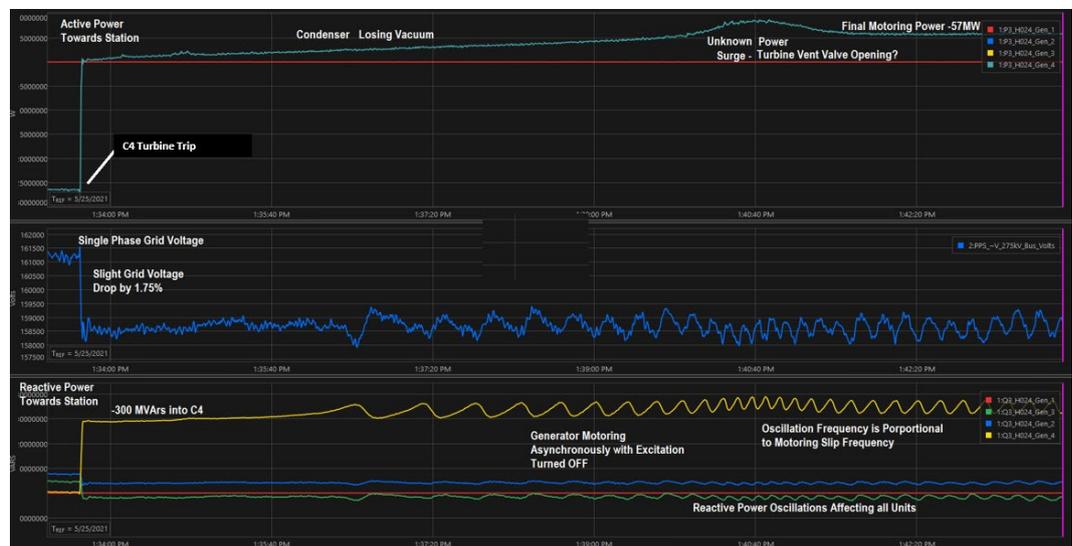
Figure 7: Electrical trends – motoring event

Time	Event
13:34–14:05	<p>The turbine tripped (closure of steam supply valves) due to the loss of AC and DC supplies to the governing oil system and resulted in the turbine/generator transitioning from generating power to absorbing power from the grid. This is called 'motoring'.</p> <p>Motoring of a generator occurs when the generator is being driven by the system it is connected to, rather than driving the system itself. This can happen when the generator is not producing power but is instead consuming power from the system, which can lead to mechanical stress and potential damage to the generator.</p> <p>The generator was actively absorbing power from the grid, operating as an asynchronous motor, without any cooling systems functioning.</p> <p>The generator protection system has reverse power protection to disconnect the unit from the grid in this situation. However, due to the lack of DC power supply this protection was not able to operate.</p> <p>The turbine/generator was motoring at ~3,000 rpm without bearing lubrication due to the loss of both AC and DC power supplies. This generated excessive heat, melting the bearings and damaging the shaft, which resulted in shaft failures in several locations.</p> <p>The loss of AC and DC power supplies resulted in the loss of sealing oil supply and the release of hydrogen through the shaft seals resulting in an explosive mixture, which is likely to have been ignited by the elevated temperatures on the shaft, resulting in rapid hydrogen combustion/explosions.</p>

14:06 The incident ceased when the generator suffered a significant electrical fault, the magnitude of which resulted in considerable damage to the generator transformer and in the de-energisation of the Calvale substation. The motoring ceased, the turbine generator stopped rotating and the incident reached its conclusion.

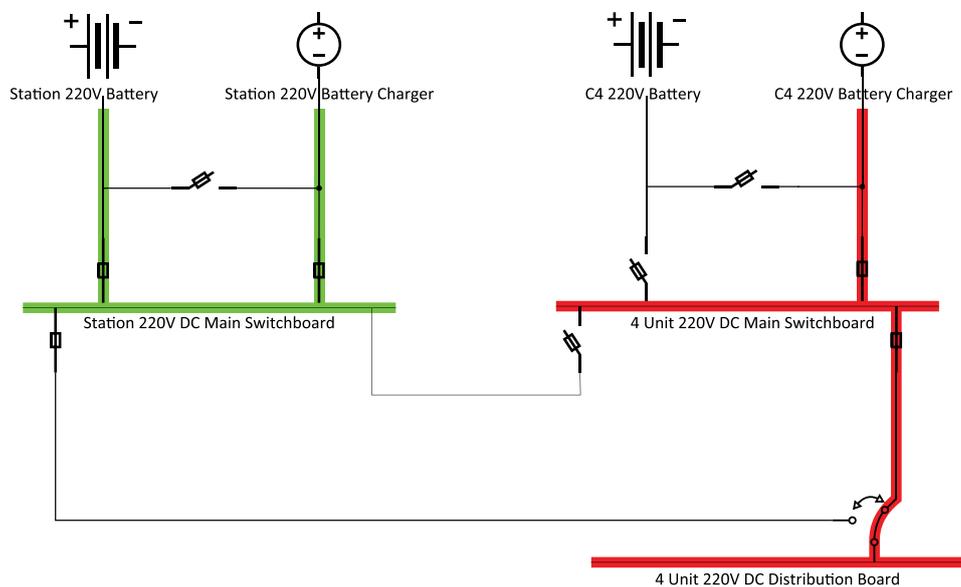
Figure 8: DC configuration 25/05/2021 13:34. Colours denote different circuits.

At the time of the Unit C4 incident, this interlock prevented the Unit C4 220V battery from being connected until the Station Interconnector was opened. This resulted in a circuit configuration as shown in Figure 8.

Therefore, following the opening of the Station Interconnector, Unit C4 220V DC Main Switchboard's sole source of supply was the Unit C4 220V battery charger.

In this configuration the reliability of the supply to the Unit C4 220V DC Main Switchboard is reduced to the reliability of the AC system powering the Unit C4 battery charger.

The key interlocking circuits have been modified to enable batteries to be paralleled but not battery chargers. This will ensure that during switching operations a battery can always be connected to provide necessary redundancy for critical protection circuits.

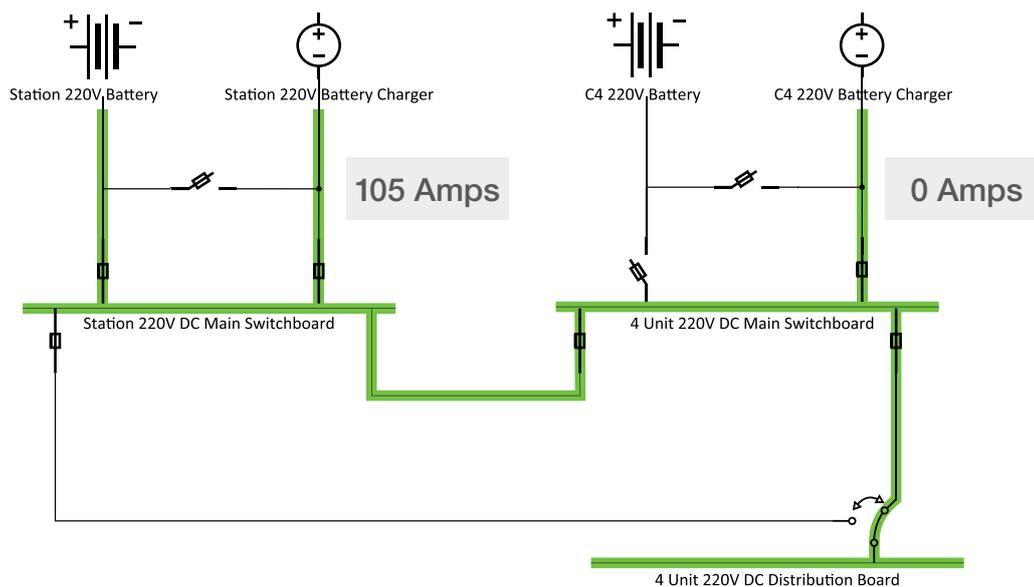
Figure 9: Battery charger current when operating in parallel – 25 May 2021 13:32

Despite the Unit C4 battery charger being set to a higher voltage than the Station battery, the actual Station and Unit C4 battery charger currents immediately prior to the opening of the Station Interconnector were as shown in Figure 9.

The Station 220V battery charger was providing all the load. On opening the Station Interconnector the Unit C4 220V battery charger had to detect the voltage drop and raise output to maintain the voltage. The Unit C4 220V battery charger failed to respond quickly enough to maintain the DC voltage before the loss of the AC supply. Once the AC supply was lost the Unit C4 220V battery charger had no opportunity to recover the voltage.

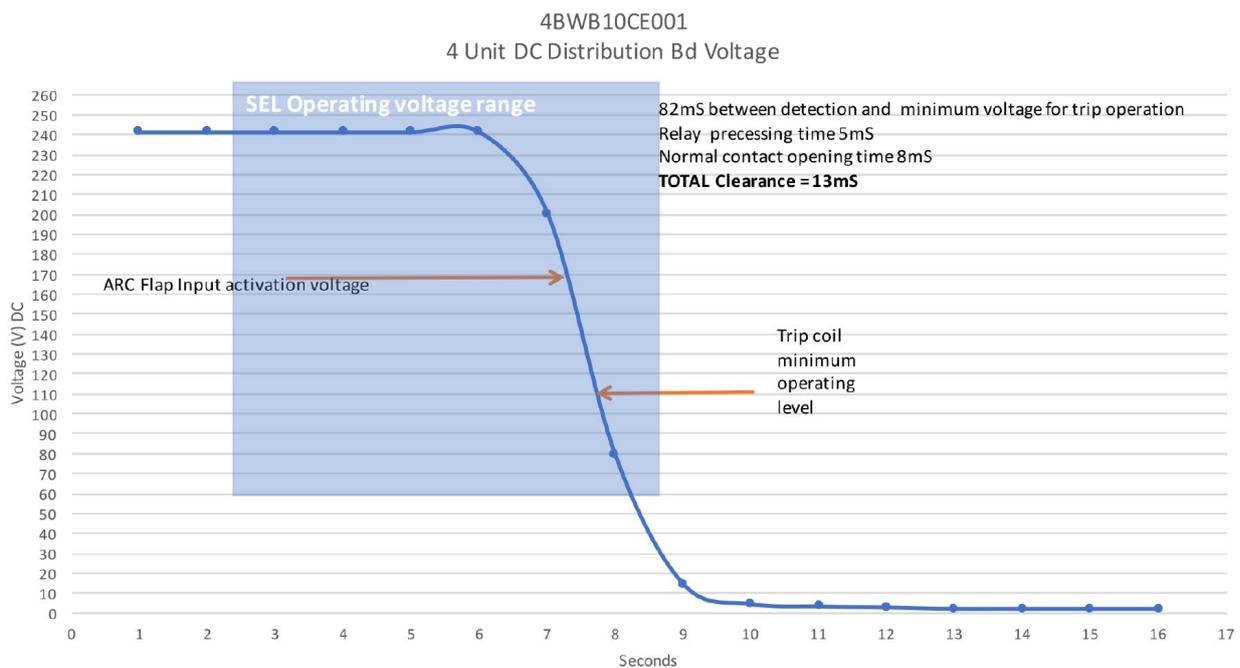
Figure 10: Unit C4 incident DC decay and arc flap activation

The loss of AC supply was a result of the 6.6kV incomer circuit breakers tripping. Protection relay alarm logs and subsequent testing have confirmed that the trip function was the 'arc flap' protection.

The loss of DC will simulate a 'normally closed' contact opening and initiate a trip.

Figure 10 plots the DC voltage decay during the incident against the arc flap protection parameters. In this case, the manner in which the DC voltage decayed (gradually rather than immediately) was such that there was sufficient time and voltage for the protection relay to trip the 6.6kV circuit breaker.

The arc flap protection logic has been modified with electrical current conditioning such that it will only trip if the arc flap switch operates in association with a high electrical current. This will ensure the arc flap protection will be resilient to short term deviations in DC supply.

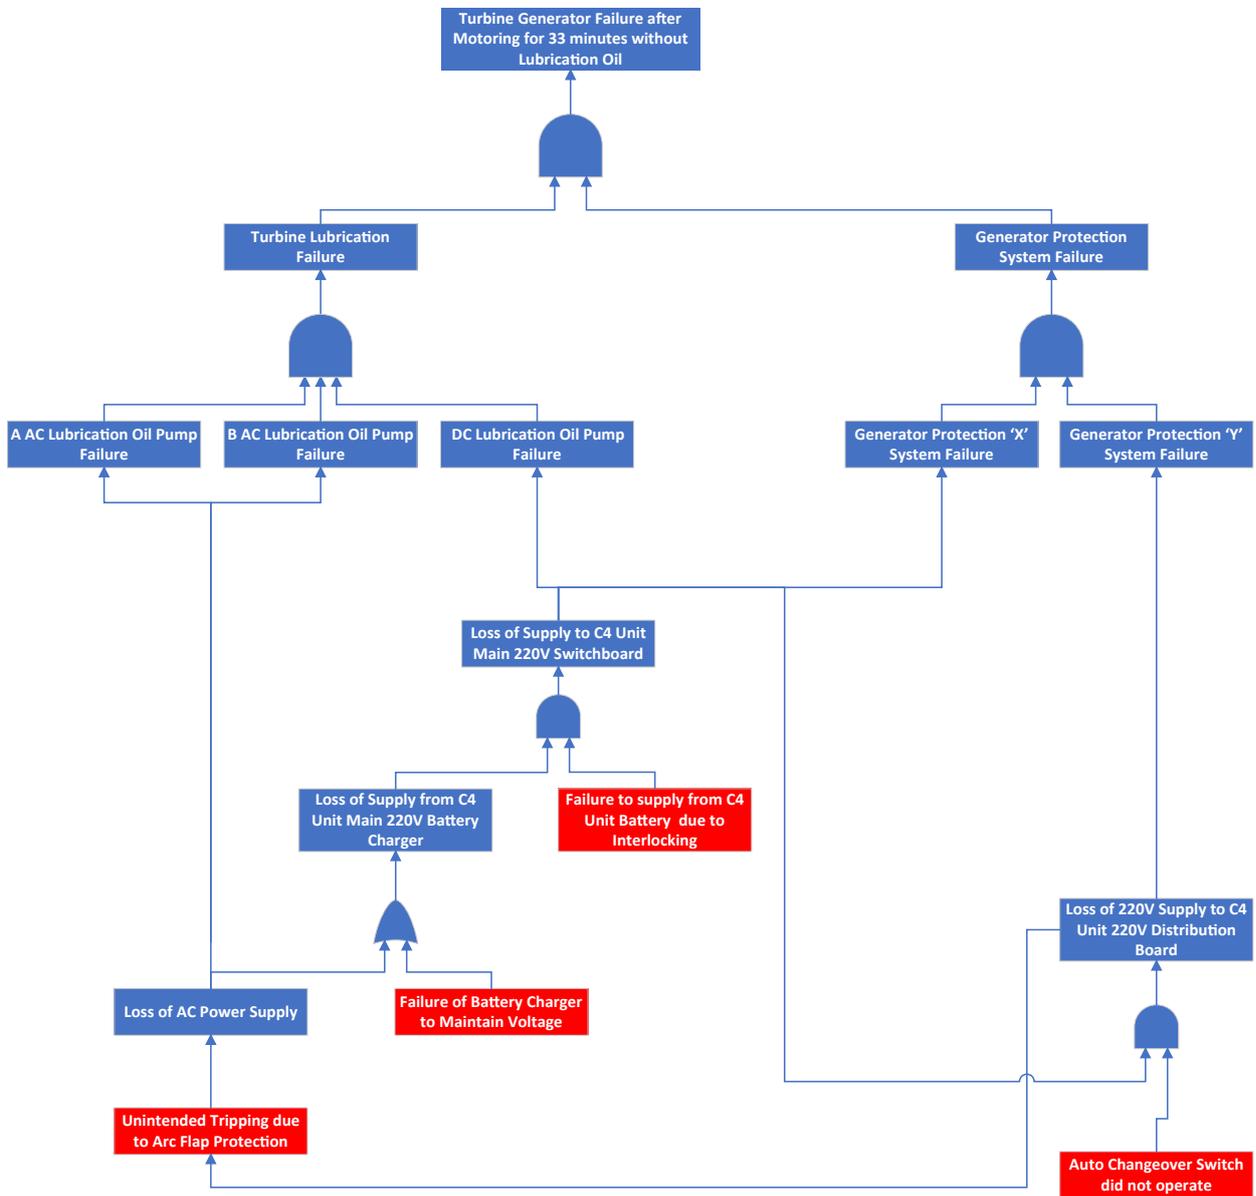
Figure 11: Unit C4 event simplified fault tree

The fault tree shows that the turbine generator failure required the failure of the entire turbine lubrication system and back-up systems:

The generator protection systems failed to disconnect the generator from the grid during the motoring event due to:

The significant contributors to the Unit C4 incident (identified in red in Figure 11) have been identified, and are summarised below in order of importance:
