# **Callide Power Station Unit C3 Incident Report**

# **Callide C3 Significant Pressure Event**

Root Cause Analysis Investigation Report

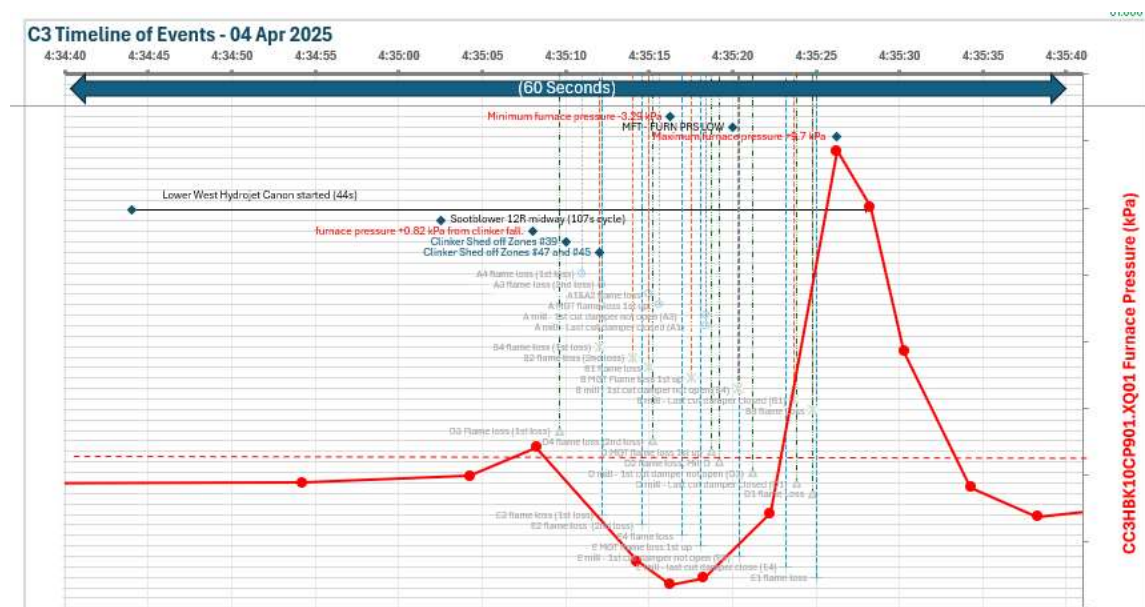
**Figure 5 - Clinker Fall Timeline with Key Events Superimposed**

The timeline presented in Figure 5, is derived from control system data. It highlights the pressure in the furnace with key events superimposed onto the timeline. It shows a staggered sequence of flame loss detections across the mills over a 16-second window, beginning after the clinker fall.

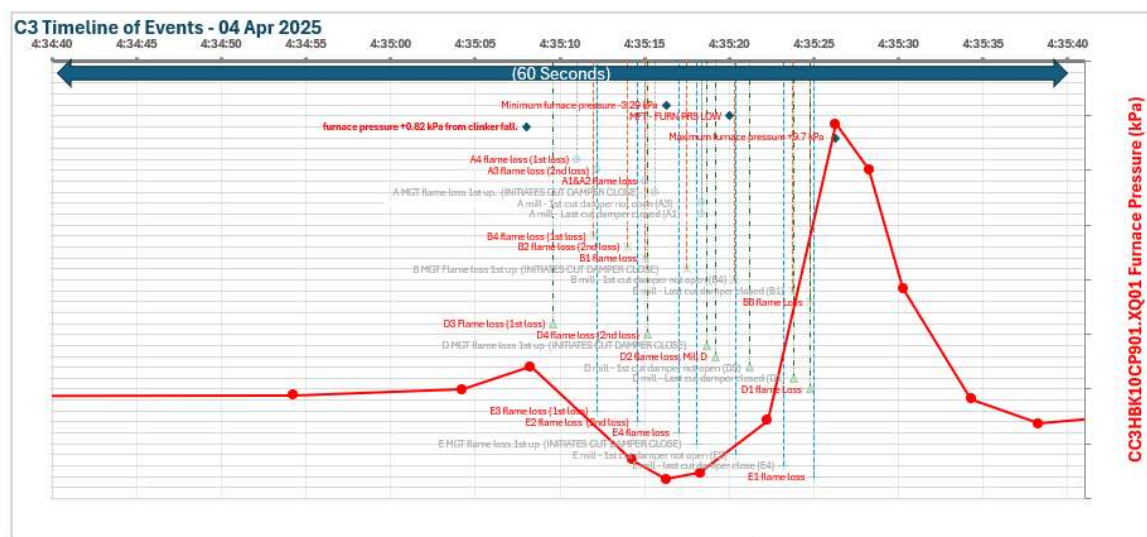
**Figure 6 - Incident Timeline Highlighting All Flames Out**

Figure 6 below presents a timeline generated from control system data, highlighting the pressure in the furnace with key events superimposed onto the timeline. This figure shows the clinker fall. This timeline underpins the subsequent event analysis and is referenced throughout this report

Figure 6 also highlights that three flame detectors continued to show false positive flame indications after the fuel isolation dampers had closed - despite there being no active combustion - indicating performance issues in the flame detection system.

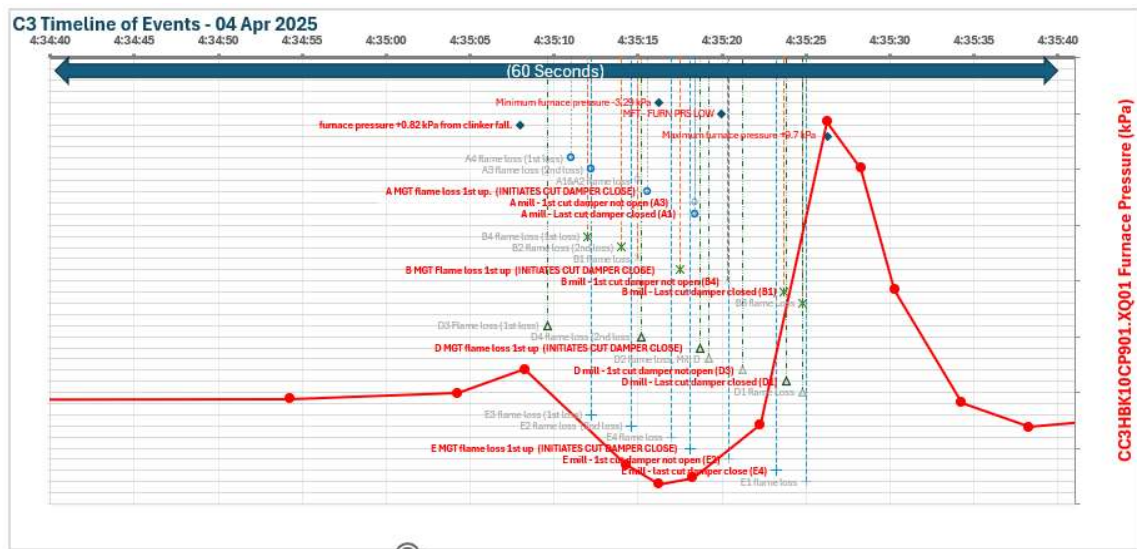
**Figure 7 - Incident Timeline and Confirmation of Fuel Isolation**

Figure 7. However, fuel continued to enter the furnace until fuel flow was ceased by the closing of either the PA isolation damper or fuel cut dampers.

The control system timeline highlights the sequence of flame losses, and the corresponding fuel cut damper activations. This timing confirms the delay between initial combustion loss and full fuel isolation, a critical factor in the escalation of the event.

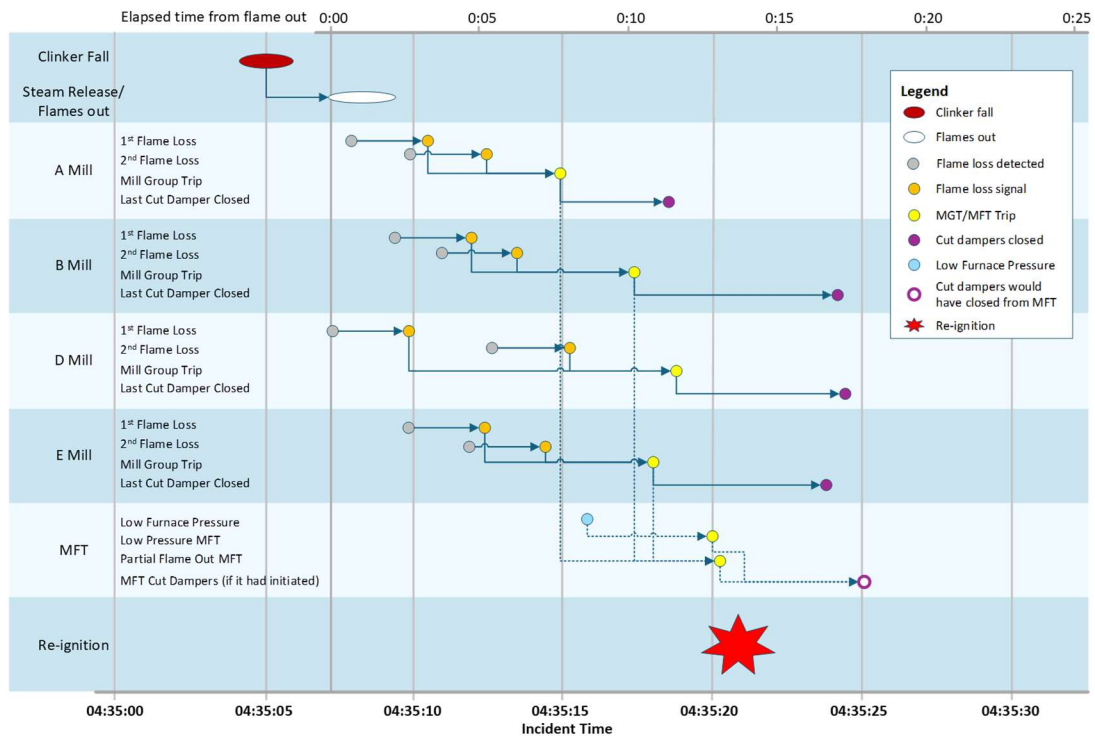
**Figure 10 - Shutdown Logic Timeline for the Boiler Protection System**

Figure 10 shows the shutdown logic timeline for the boiler protection system, including the inherent delays. These latent delays in the C3 boiler protection logic contributed to the root cause: a delay in flame loss triggering a Mill Group Trip or Master Fuel Trip.

The latent delays embedded in the C3 boiler protection logic directly contributed to the delayed initiation of the Mill Group Trip and Master Fuel Trip. These delays are a key factor in identifying the failure to promptly isolate fuel as a root cause of the event.

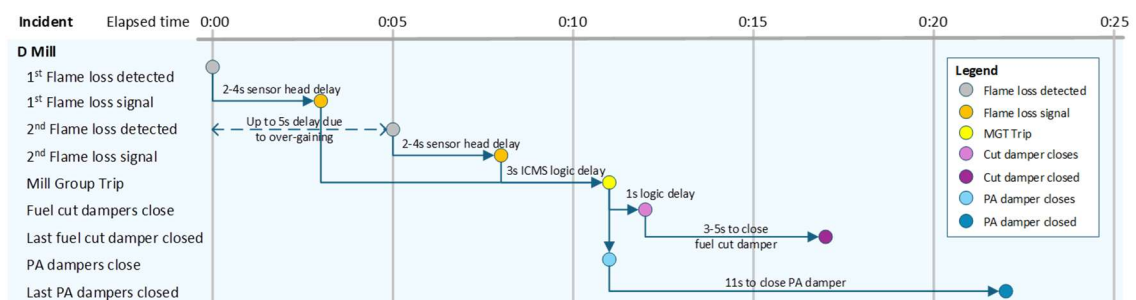
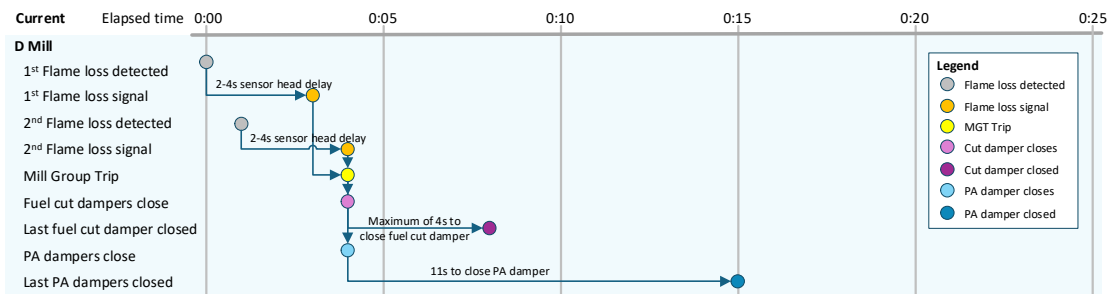
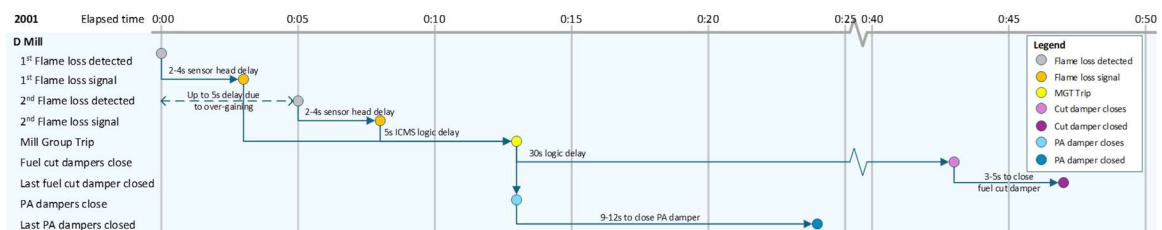
**Figure 11 - Boiler Protection Shutdown Logic Flow from Clinker Fall to Cut Damper Isolation (D Mill)**

Figure 11a to Figure 11c shows the shutdown logic timeline for the boiler protection system, for a specific mill (Mill D), including the possible effects of over-gaining of the flame detectors. Figure 11a shows the situation at the time of the incident. Figure 11b shows the situation post incident, after the issues have been rectified – the time from flame loss detected until cut dampers closed has reduced from 17 seconds to 8 seconds. Figure 11c shows the original situation at commissioning of C3 in 2001. It should be noted that closing the primary air damper was the original method of preventing re-ignition and the original configuration was in place until 2012 at which time some improvements were made to reduce the time of the MGT.

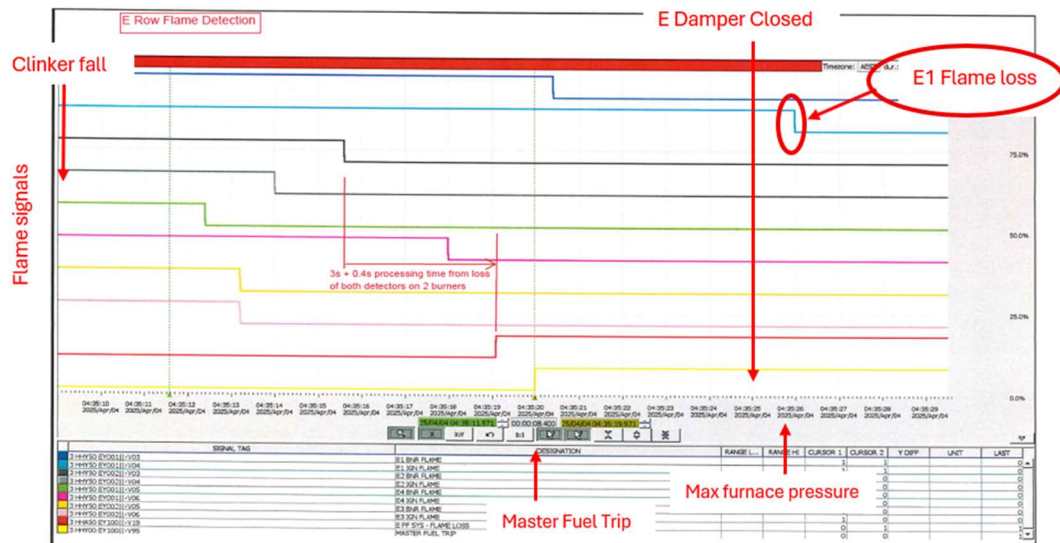
**Figure 12 - E Mill Flame Detection Signals Through the C3 Event**

Figure 12 shows the E Mill flame detection system displaying a flame (a false positive) after pulverised fuel was eliminated through closing of the mill cut dampers. For example, because of this blinding function, E1 flame loss is acknowledged approximately 7 seconds after its Mill Group Trip is initiated.

These impairments increase the delay in initiating fuel isolation and reduce system reliability under abnormal combustion conditions.

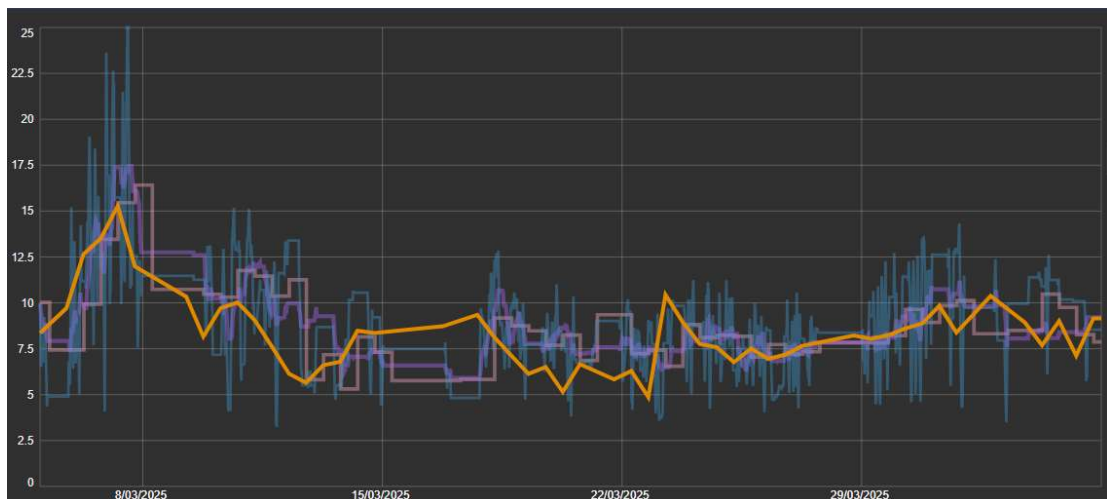
**Figure 14 - Iron Oxide Levels Content in Coal Feed Supply Previous 4 Weeks Supply**

Figure 14 shows  $\text{Fe}_2\text{O}_3$  variation over the four weeks preceding the event. The chart shows iron oxide content over time using several data sources: Orange represents the Lab 12-hour shift

There is currently no real-time integration between measured iron oxide levels in incoming coal and the operation of the Callide C units. While technically feasible, the ability to use this data to actively influence unit operations is limited. This gap limits visibility of fuel risk and leaves the units exposed to variable coal quality.

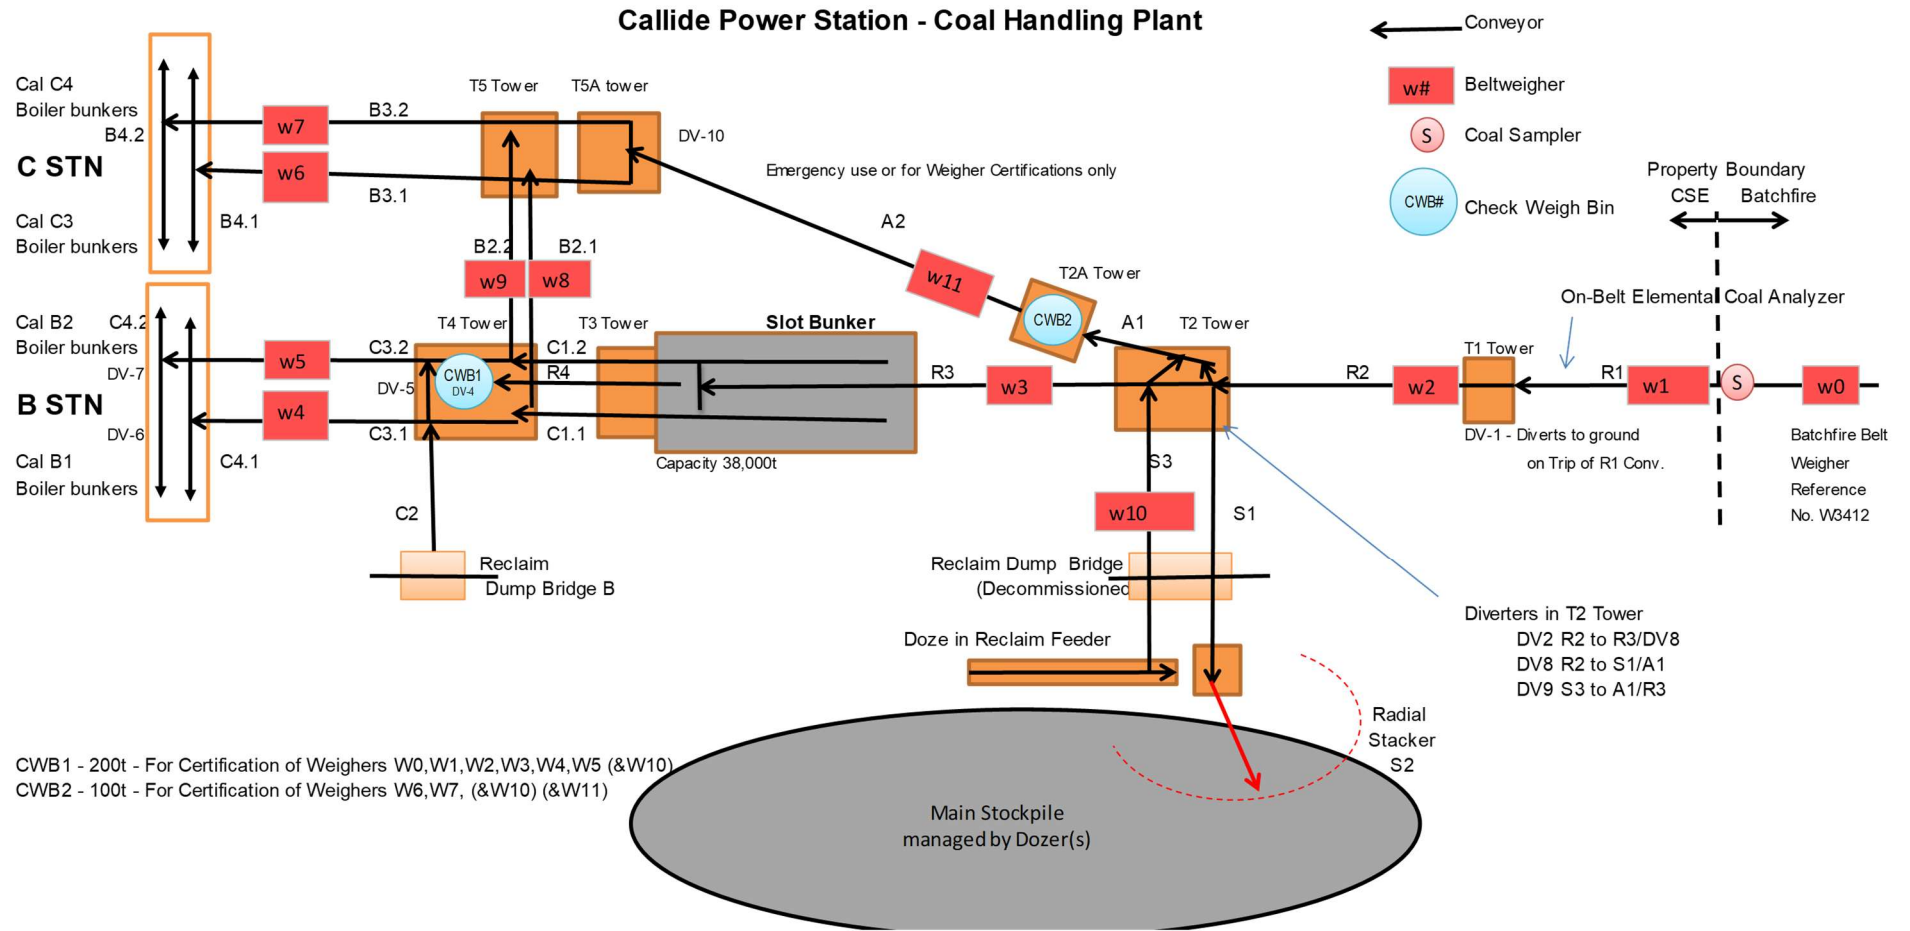
**Figure 25 - Callide Coal Handling Plant Supply Configuration Schematic**

The coal handling arrangement into Callide Power Station is shown in Figure 25 coal handling schematic. Coal is stockpiled and managed under procedure CWP-ES-0030 - Coal Stockpile Management (May 2013), which provides guidance for handling high-moisture coal but does not address coal quality in relation to ash, calorific value or iron content. Coal blending is achieved through the management of the stockpiles and slot bunker configuration. Effective blending relies on sufficient stock levels and operational flexibility to mix coal before it enters the furnace.

station's ability to manage coal feed quality. This finding is supported by the coal supply schematic (refer Figure 25).

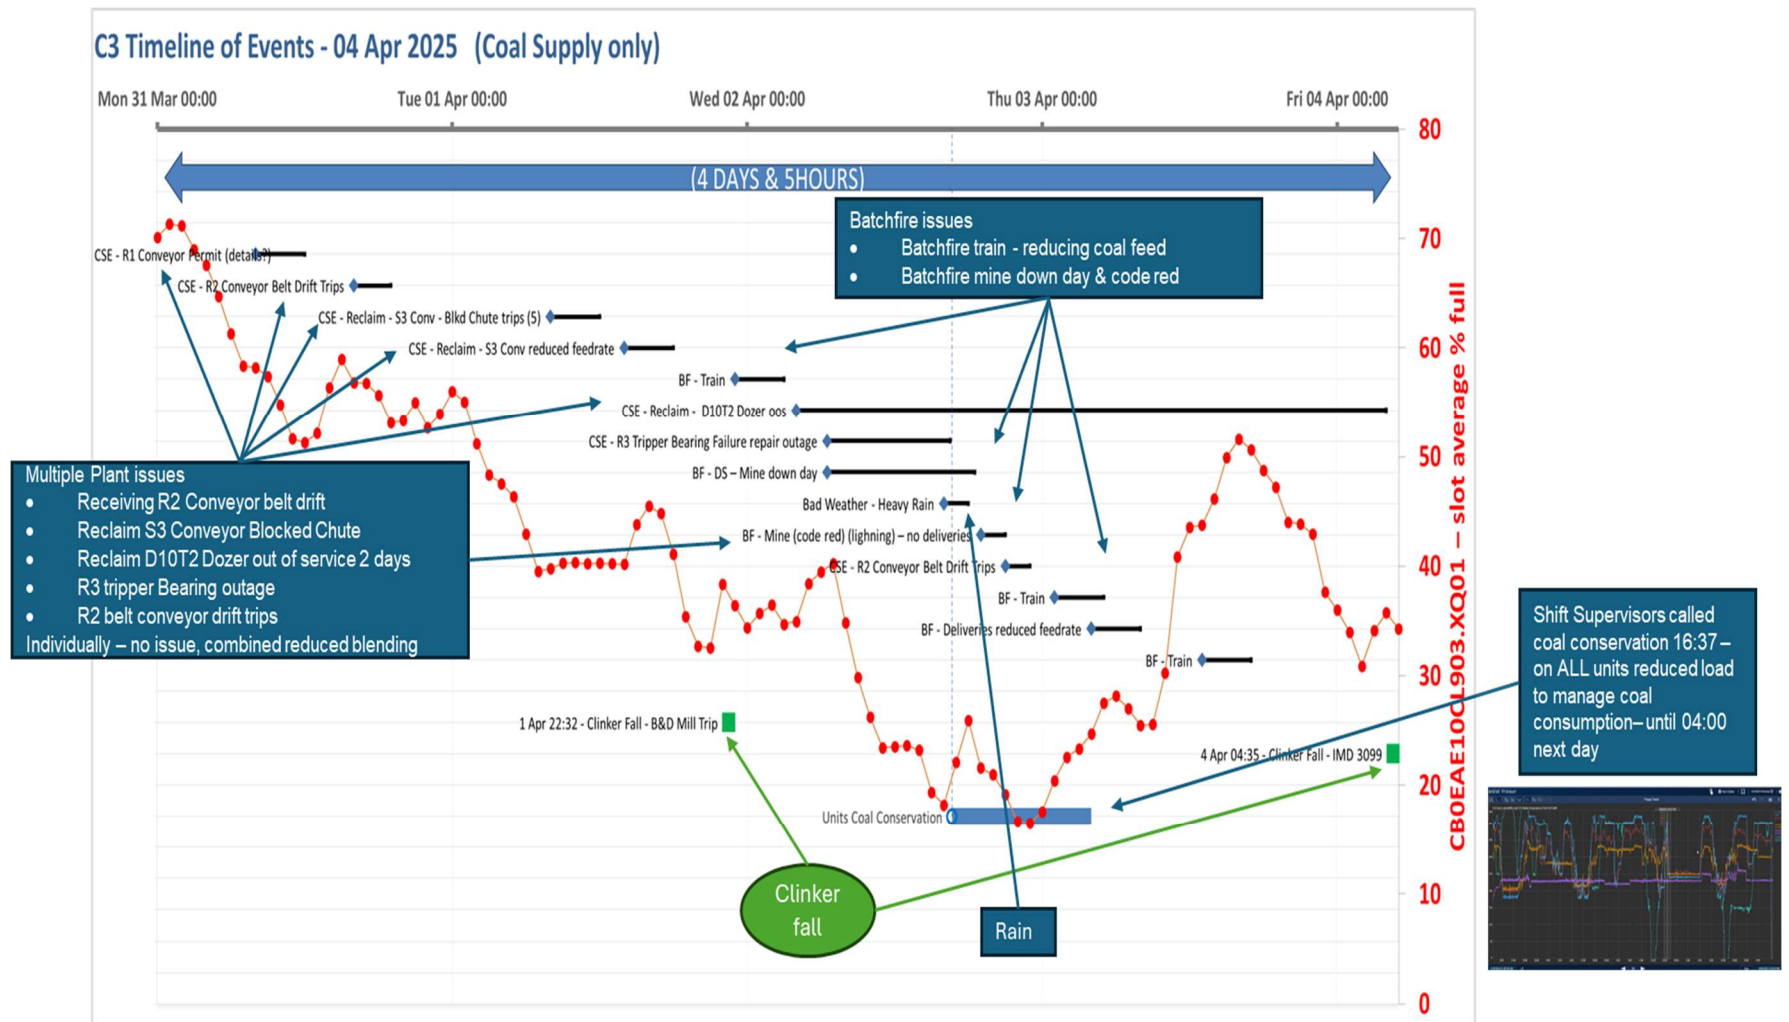
**Figure 27 - Coal Supply Timeline and Slot Bunker Level**

There was also a period of wet weather resulting in localised stockpile reclaim to find dry coal. The Slot bunker had operated at around 30% for the 3 days prior. While none of these factors alone create a significant blending issue, together they depleted accessible coal stocks and forced the station to rely heavily on the slot bunker. The delays are shown visually in Figure 26 and Figure 27.

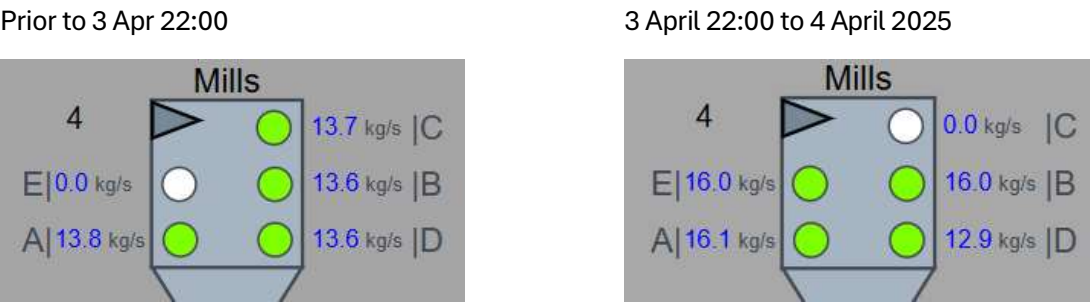
Figure 28 - C3 Mill Configurations Overview Pre Event

Figure 28 shows the mill operating loads (coal flow kg/s) and mill configurations for prior to the event. Mills typically deliver Pulverised Fuel at the same feed rate, unless an operator specifically adjusts one of the mills to different. Prior to 3 April 2025 Pulverised Fuel flow was 54.7 kg/s vs a small increase in flow to 61 kg/s pre-event. The D mill flow was reduced 6 hours prior to the event by an operator in an attempt to minimise clinkering.

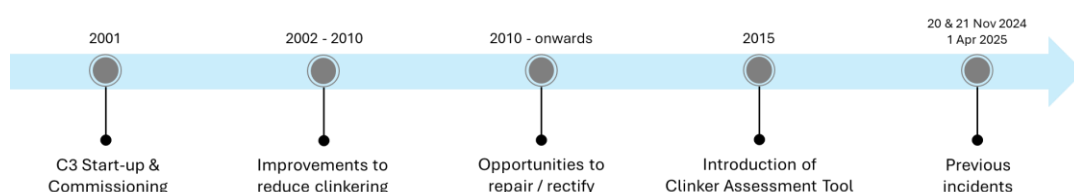
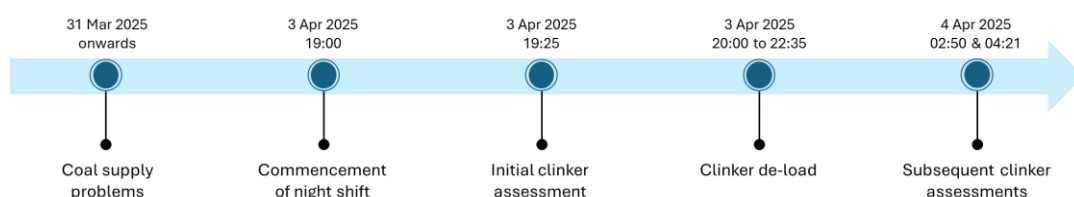
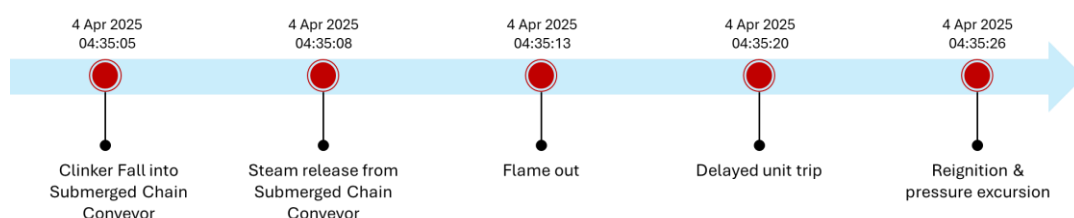
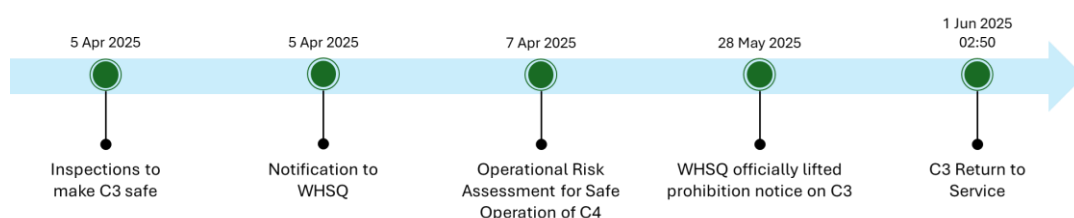
**Figure 4 – Event Timeline**

Figure 4 provides a summary of the key events with a detailed breakdown illustrated in Figure 5.

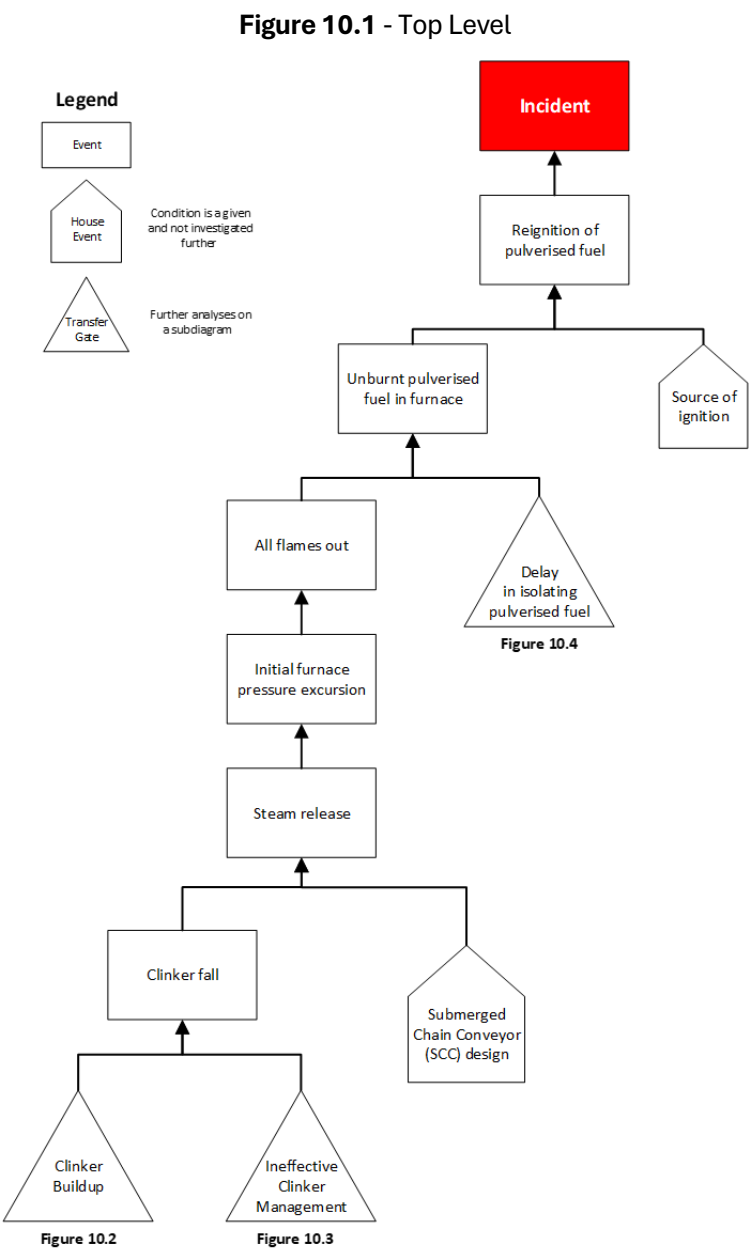
Figure 10 - Fault Tree Analysis Diagram

To support the investigation’s findings, two structured tools were applied to map what failed and why. The Fault Tree Analysis traces the sequence of events, while the ICAM Chart organises the contributing factors across each level of the ICAM framework. Together, they show how multiple weaknesses combined to allow the incident to occur and provide the foundation for the contributing factors Section 6.0.

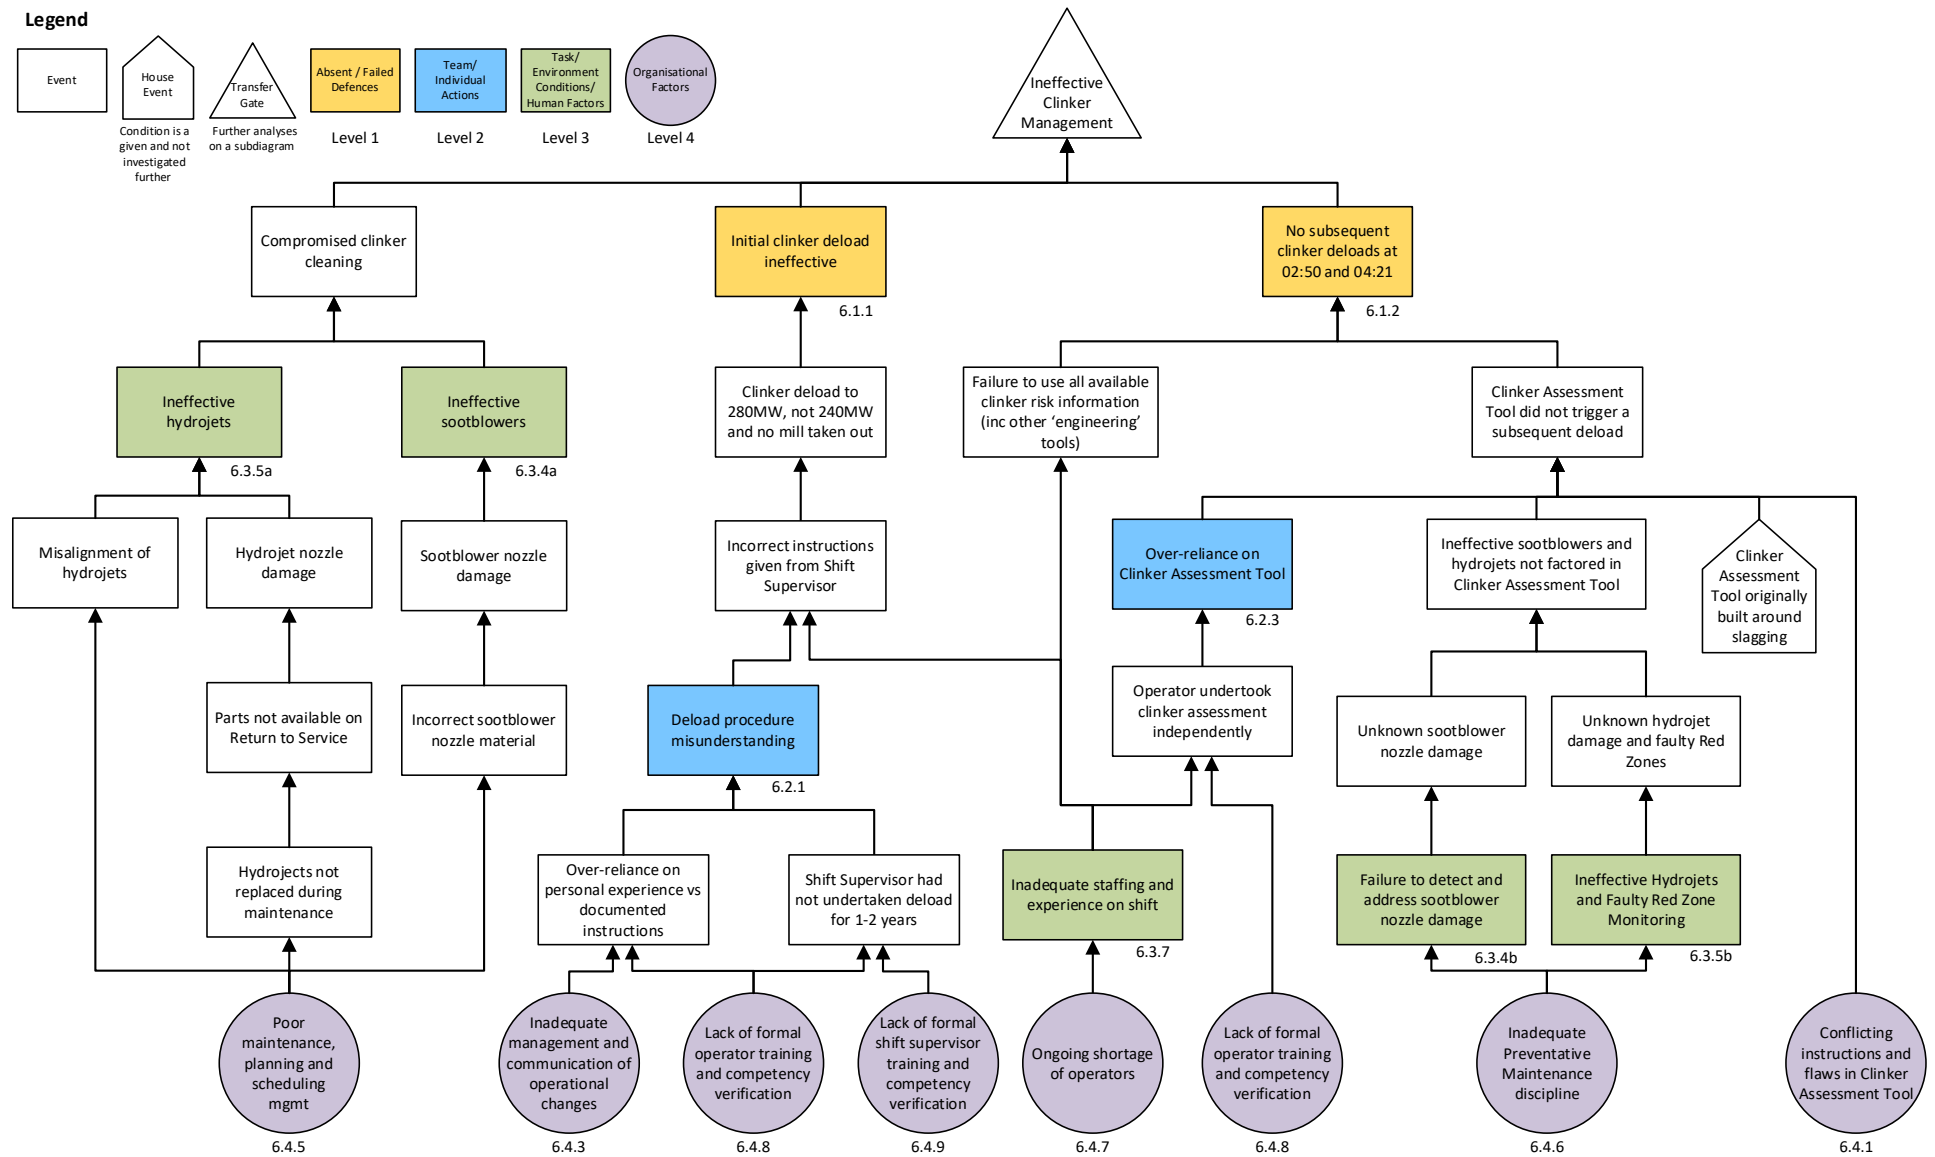
**Figure 10.3 - Ineffective Clinker Management**

The failure to detect and address sootblower nozzle damage resulted in two issues that contributed to the incident. These are noted as 6.3.4a and 6.3.4b on the Fault Tree (Figure 10.3) and ICAM chart (Table 1).

The failure to detect and address ineffective hydrojets resulted in two issues that contributed to the incident. These are noted as 6.3.5a and 6.3.5b on the Fault Tree (Figure 10.3) and ICAM chart (Table 1).

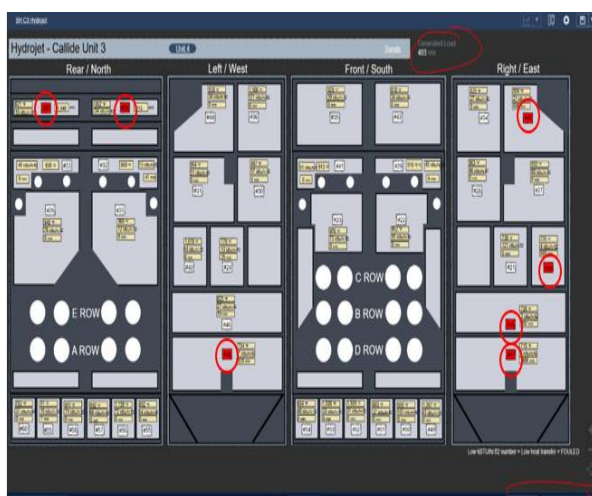
**Figure 14.1** - Seven Red Zones from Pi Vision

**Failure:** The operator treated the tool as a standalone directive rather than a decision support guide. At the time of the event, there were seven red zones (Figure 14.1), several of which had persisted for over 500 minutes. Whilst PI Vision screens were available to visualise this clinker growth build up (Figure 14.2), they were not directly and immediately accessible to panel operators.

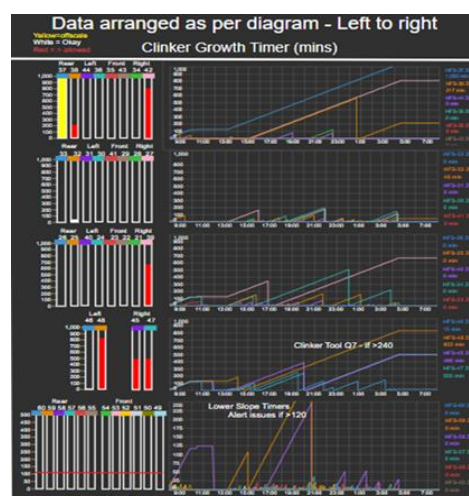
**Figure 14.2** - Clinker Growth Build Up

This overreliance on the tool as the sole trigger, combined with failure to use available monitoring systems, allowed clinker build-up to continue unchecked. It highlights the operator's inexperience, gaps in training and competency for clinker management and the operator shortage that diverted the Shift Supervisor's oversight.

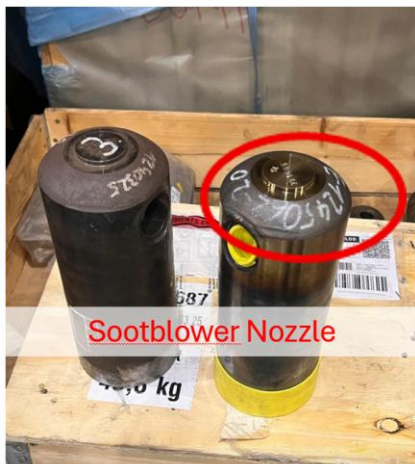
**Figure 16.1 - New Sootblower Nozzle**

**Intended Defence:** Sootblowers are designed to remove ash and clinker buildup from boiler surfaces by directing high-pressure steam through the nozzle ports. The system depends on rotating nozzles that redirect steam through side ports. Figure 16.1 is a photo of a new sootblower with the nozzle head intact. Effectiveness is reliant on Preventative Maintenance (PM) fortnightly inspections. When deemed ineffective, this would result in an additional 'yes' in the Clinker Assessment Tool and potentially trigger a deload.

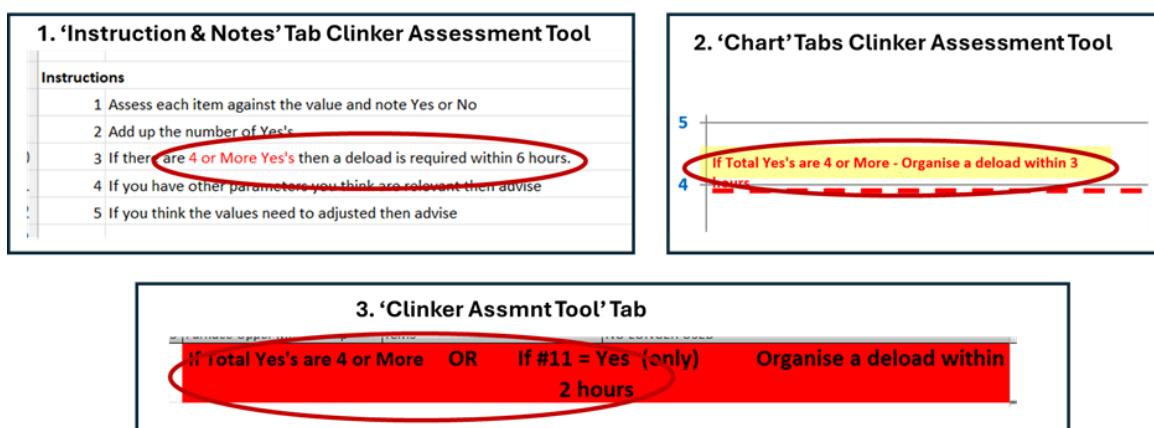
Additionally, the tool contained multiple tabs with conflicting instructions on when to deload, creating ambiguity at critical decision points (Figure 21).

**Figure 21** - Inconsistent instructions on deload in the tool - increasing likelihood of human error

This highlights that a poorly controlled tool had become a key instrument for managing clinker risk. Its design relied heavily on fragile manual steps which increased the likelihood of human error. There was no robust version control, no safeguards to prevent manual errors from disabling critical logic, and no clear accountability for maintaining or reviewing the tool's use.

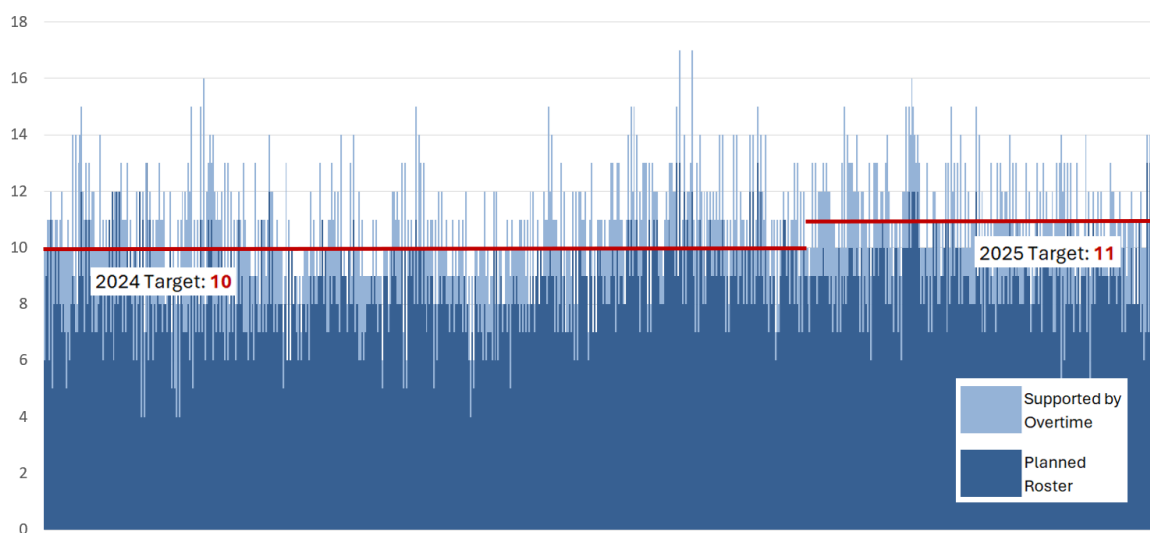
**Figure 24 - Overtime Coverage and Gaps in Target Operator Numbers**

**Failed Defence:** The operator shortage was a known and escalating risk well before the incident. Roster analysis over a 12-month period (Jan 2024 to Dec 2024) shows only 20% of shifts were staffed at planned levels, a further 54% met the requirement only by using overtime, and 26% of shifts fell short altogether (See Figure 24 and Figure 25). This gap was compounded by two further pressures:

As a result, the site continued to run shifts understaffed and reliant on overtime and newly qualified operators, undermining the shift supervisor's capacity, peer checking, on-the-job training and timely response to abnormal conditions.

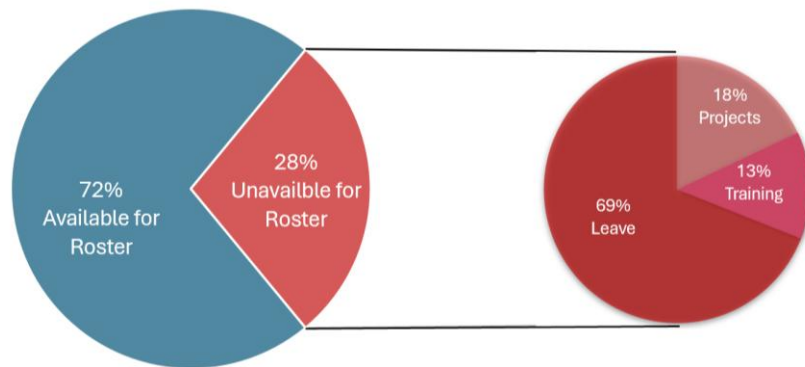
**Figure 26 - Compounding Shortage due to 'Unavailability' (Secondments, Leave, Training)**

- Retirement risk: 28% of current panel operators are due to retire within five years (Figure 27)
- Operator 'unavailability': 28% of qualified panel operators were unavailable due to secondments, training or extended leave (Figure 26)

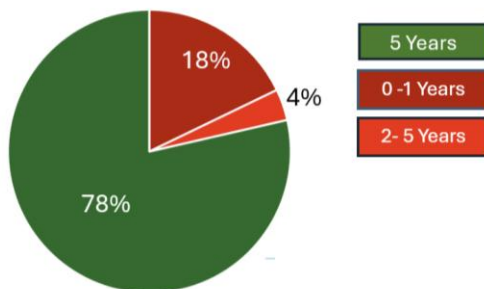
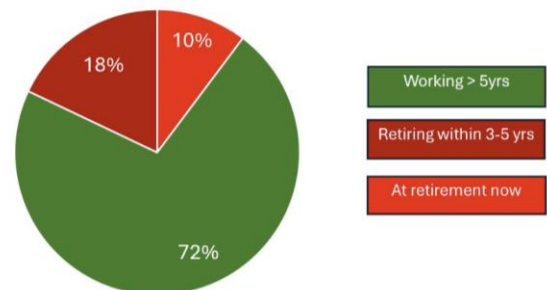
**Figure 27 - Compounding Shortage Due to Retirement**

**This demonstrates a clear failure to staff and supervise shifts to safe minimum standards, and a management failure to recognise, escalate and resource this as a critical operational risk. This normalised running with insufficient and inexperienced operators, directly undermining safe, reliable operations.**

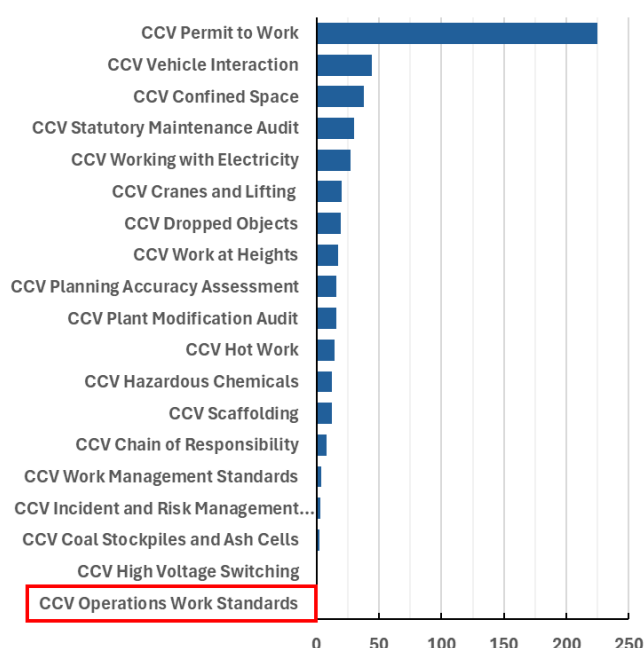
**Figure 30 - CCVs by Type Completed at Callide for Financial Year 2024/2025**

Despite this, the breakdown (Figure 30) shows the majority focused on lower risk checks like Permits to Work, which made up 44% of the total. No CCVs were done for Operations Work Standards, which include critical processes like Shift Handovers. The last CCV for shift handovers was completed in April 2022.

**Without clear leadership accountability and a realistic, leader-driven, risk-focused CCV program, the system rewarded quantity over effectiveness, leaving key safeguards unverified when they were needed most.**
