Callide Unit C4 turbine generator failure – 25 May 2021

Technical investigation summary

13 February 2024

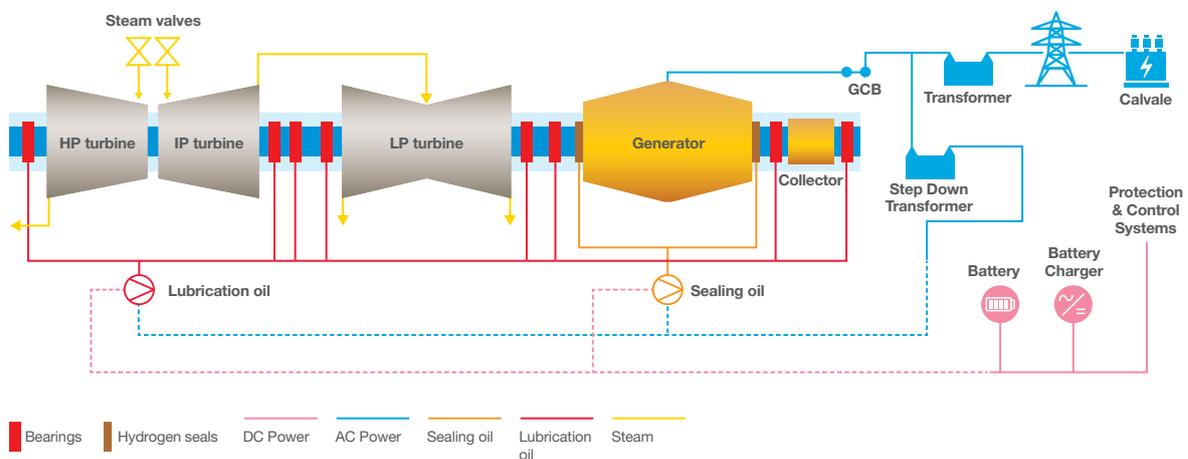
Figure 2: Callide C turbine generator overview

The turbine lubrication system provides lubrication oil to the turbine and generator bearings, allowing the rotor to rotate with minimal friction. This system has redundancy and includes two AC pumps and an emergency DC pump.

The generator sealing oil system creates an oil pressure seal preventing the hydrogen gas, which cools the generator, from escaping. This system has redundancy which includes an AC pump and an emergency DC pump.

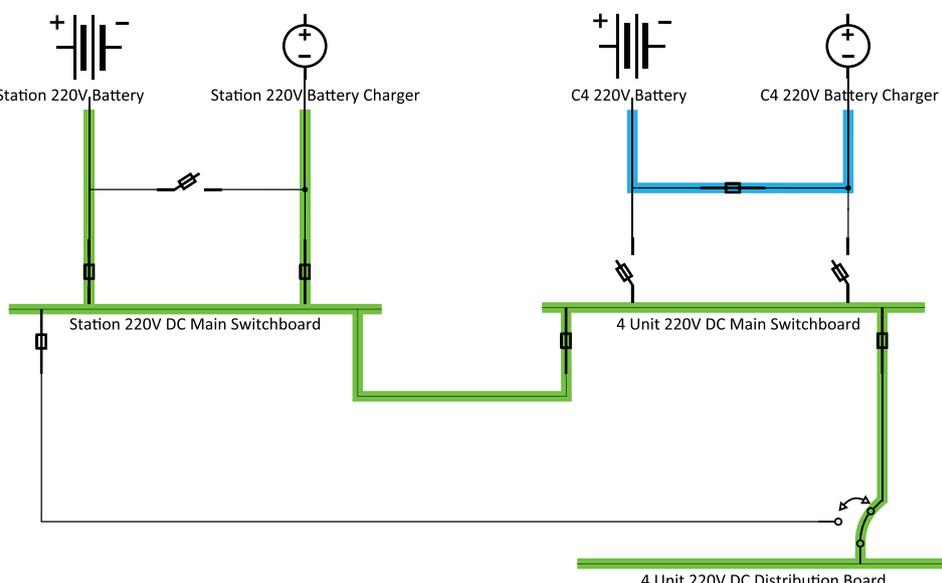
Time	Event
24 May 2021	
14:08	<p>C4¹ 220V battery charger energised and returned to service in offline charging mode (connected to C4 battery only). Offline charging is required to ensure that the battery is fully charged prior to being returned to service.</p>

<p style="text-align: center;">Figure 3: DC configuration 24/05/2021 14:08. Colours denote different circuits.</p>
20:00	C4 220V battery was successfully charged and maintained in a fully charged state.

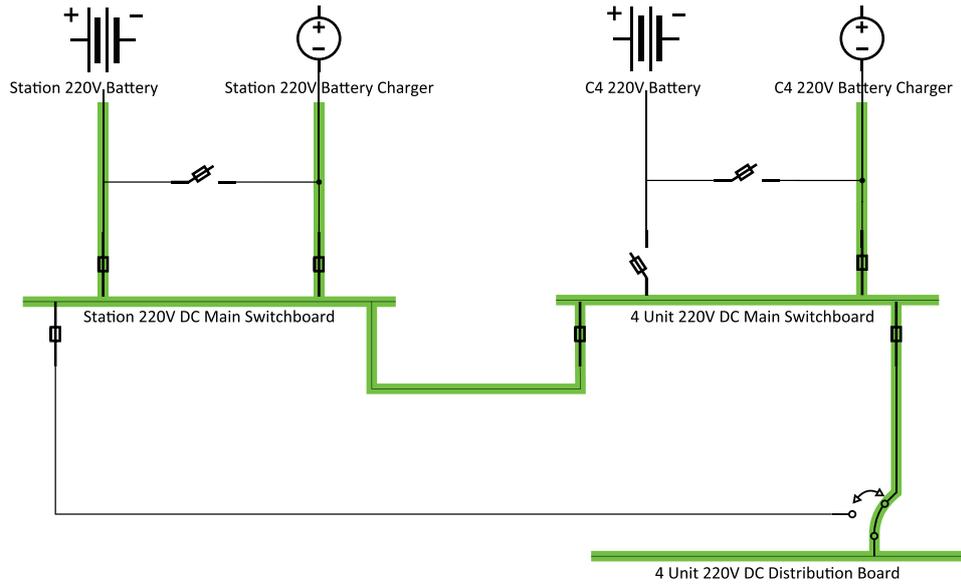
Figure 4: DC configuration 25/05/2021 13:32.

13:32	C4 offline battery charger circuit was opened and C4 220V battery charger was connected to Unit C4 220V DC Main Switchboard. Configuration as per Figure 4.
--------------	---

13:33	Unit C4 to Station Interconnector opened (initiating event), Unit C4 220V DC voltage decayed to zero volts.
--------------	---

Despite successfully charging the Unit C4 battery on the day prior to the incident, the Unit C4 220V battery charger failed to maintain the voltage on the Unit C4 220V DC Main Switchboard following the opening of the Station Interconnector.

The Station 220V battery charger was providing all the load. On opening the Station Interconnector the Unit C4 220V battery charger had to detect the voltage drop and raise output to maintain the voltage. The Unit C4 220V battery charger failed to respond quickly enough to maintain the DC voltage before the loss of the AC supply. Once the AC supply was lost the Unit C4 220V battery charger had no opportunity to recover the voltage.
